An Investigation of Surface Characteristics of Enamel Treated with Infiltrative Resin: A Scanning Electron Microscopy Study

A thesis submitted in partial fulfillment of the requirements for the degree of Master of Science
in Dentistry at Virginia Commonwealth University.

Director: Dr. Eser Tüfekçi,
D.D.S., M.S., Ph.D., M.S.H.A.
Professor, VCU Department of Orthodontics

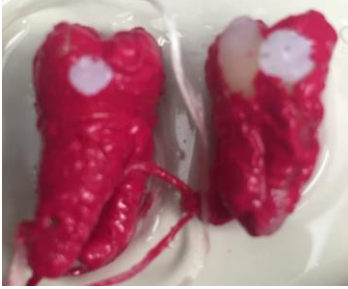
Figure 1: Confirmation of WSLs on Pilot Teeth.

The acidic solution was prepared according to the protocol outlined by Kumar et al.²⁷ by mixing 2.2 mM calcium chloride (Fisher Bioreagents, Hampton, NH), 0.05 mM acetic acid (Fisher Bioreagents, Hampton, NH), 2.2 mM monopotassium phosphate (EMD Millipore, Billerica, MA) and titrating the contents to a pH of 4.4 with 1.0 M potassium hydroxide (Fisher Chemical, Hampton, NH). A small hole was drilled near the apex of each tooth so that a non-fluoridated dental floss could be used to suspend teeth in the acidic solution. Samples were kept in the demineralizing medium for 10 days. Each day, the acidity of the solution was checked with a pH meter to ensure the solution was stable at or near 4.4 pH, and the tooth surfaces were examined for the development of white spot lesions (Figure 1).

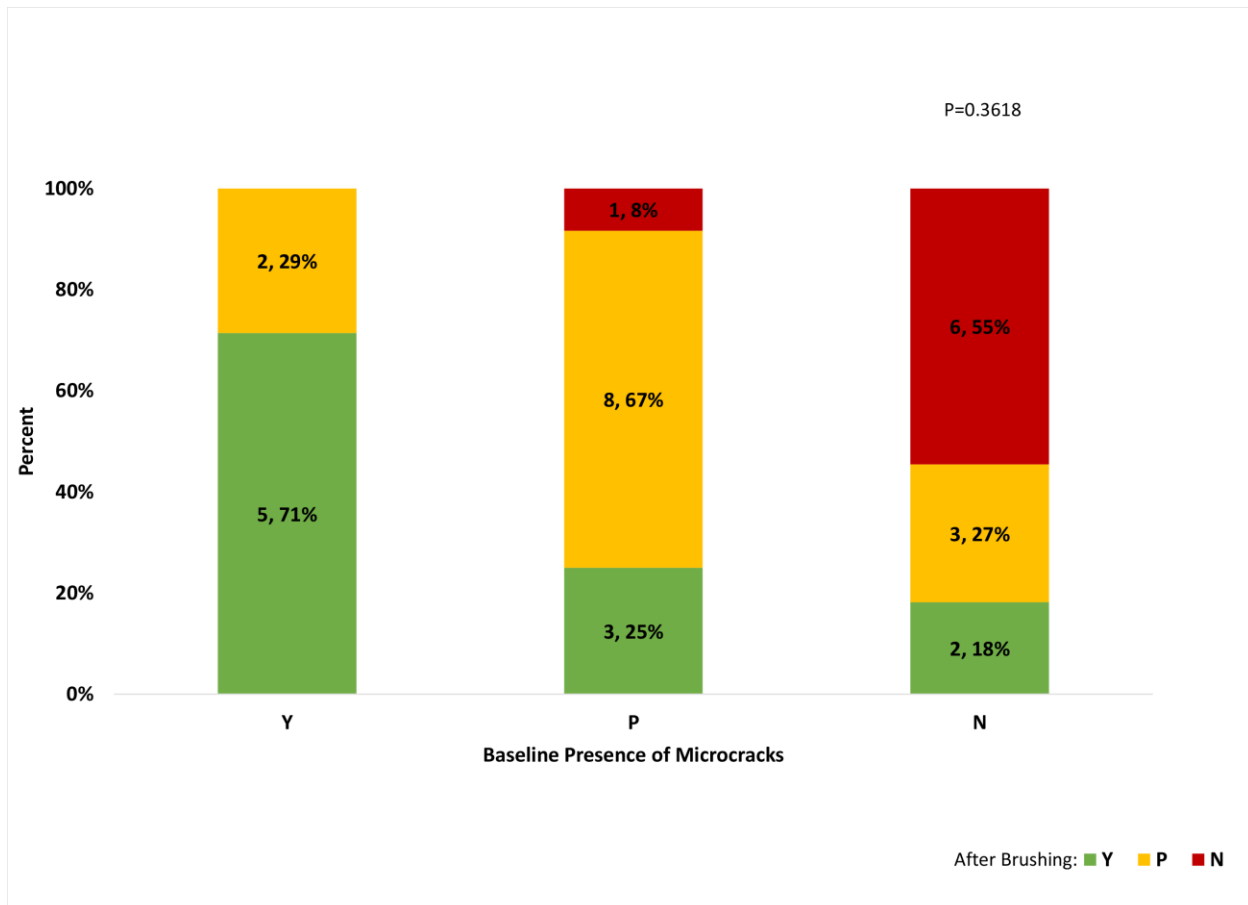
Figure 9: Changes in Presence of Microcracks After Simulated Brushing.

Microcracks and fissures present on the resin surface were common findings throughout the samples. For this study, fractures were defined as fissures within the resin-enamel interface where a cleft-like gap could be visually detected at 250X magnification. Microcracks displayed a similar appearance to fractures, however the surface of the resin appeared intact, without gap formation. Figure 9 displays the distribution of all samples regarding microcracks at the surface before and after toothbrushing. At T1, 63% of the images displayed microcracks present at some level (either present or partially present), and 37% of the images had a change in classification after toothbrushing. Of images which were found to have presence (Y) of microcracks at T1, 71% of these images were still found to have microcracks after toothbrushing, and no pair of

images evaluated showed enough of a decrease in microcracks to be defined as absent of this characteristic. Twelve images were found to have partial occurrence of microcracks at baseline. Of these images, 25% of the images were judged to have more microcracks uncovered at T2, and 8% had removal of microcracks from the surface. Similar to the changes in enamel rods, while changes in the distribution of microcracks did occur between groups, these differences were not found at a level of statistical significance to result in a predictable change in any particular direction ($p = 0.3618$).
